TECHNICAL MEMORANDUM 226

ROCKET SLED IMPACT TESTS
OF BULK CONTAINERS FOR ETIOLOGIC
AGENT STORAGE AND SHIPPING

ROCKET SLED IMPACT TESTS OF BULK CONTAINERS
FOR ETIOLOGIC AGENT STORAGE AND SHIPPING

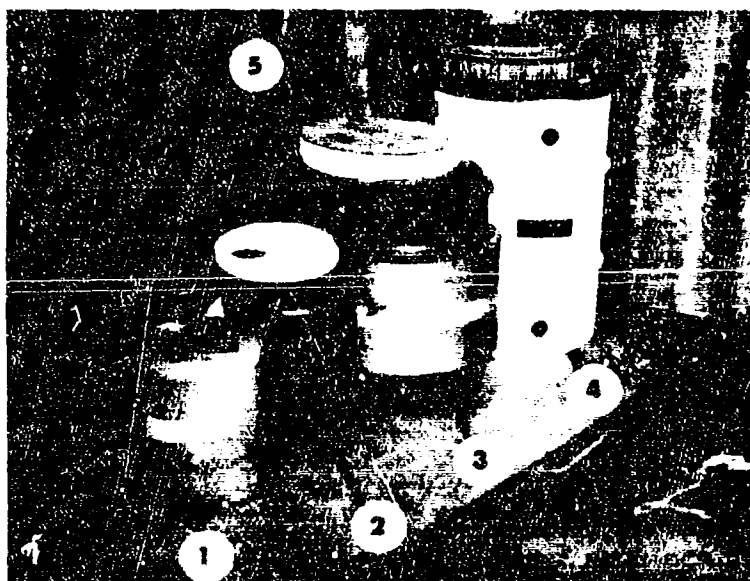
FIGURE 2. Components for XM594, 5-gal Capacity System. (1) Primary container, (2) protective shell for primary container, (3) intermediate container, (4) outer container, (5) blocking and cushioning. Non-particulate, liquid absorbent cushioning material is uniformly distributed around primary container.

The innermost metal containers (Item 2, Fig. 2) of the 5-gallon systems proved inadequate. These containers were originally equipped with bail handles that were removed for tests; however, the bail mounts welded to the drum bodies provided an easy starting point for side-wall rupture. Areas adjacent to side-seam welds in thin-gauge container metals are also susceptible to fracture. Figure 14 illustrates this characteristic failure.

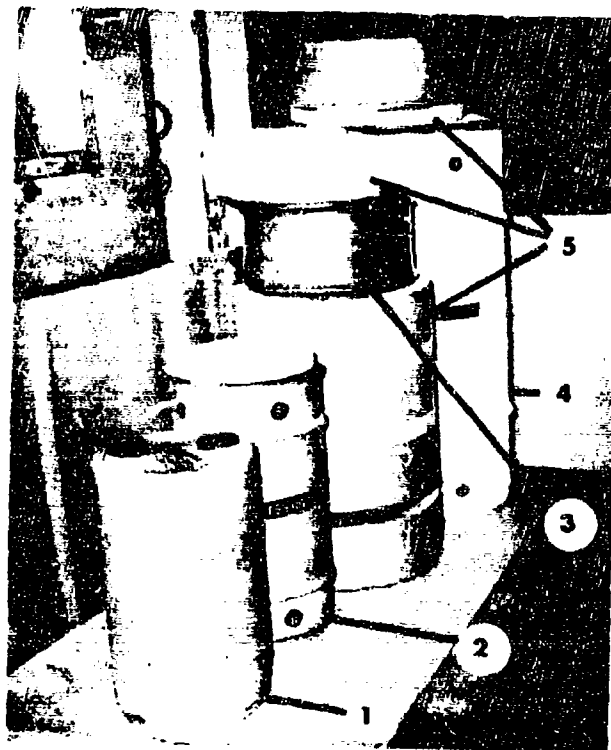
FIGURE 3. Components for XM595, 15-gal Capacity System. (1) Primary container, (2) protective shell for primary container, (3) intermediate container, (4) outer container, (5) blocking and cushioning. Non-particulate, liquid absorbent cushioning material is uniformly distributed around primary container.

Two 15-gallon systems were impacted in one attitude only and each met the established criteria. One item consisted of the basic assembly as shown in Figure 3; the second item was fitted with a plywood crate and energy absorber on the impact side (Fig. 12). These two systems were impacted as trials to obtain engineering data, so additional replicates for qualification were not scheduled.

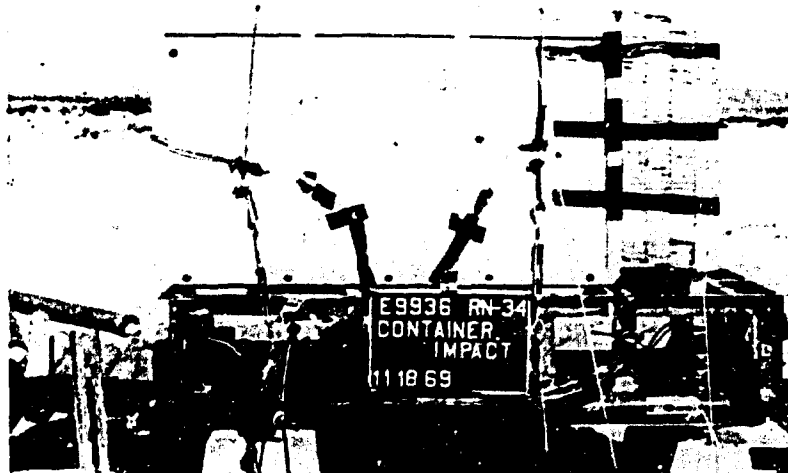
FIGURE 12. Fifteen-Gallon System with Crate and Energy Absorber.

Two design concepts of the 15-gallon system (Figures 5 and 12) were impacted to obtain engineering data for final determination of energy absorber requirements. These limited tests indicated that the initial design of the basic system is adequate to meet prescribed test criteria without protection of an added overpack and energy absorber.
